CARLO GAVAZZI SPACE SpA	<h1>AMS02-PDS</h1>	N° Doc: PDS-RP-CGS-120 Doc N°:	
	PDS-PFM THERMAL VACUUM TEST REPORT	Ediz.: 1 Issue:	Data: SEPT 2009 Date:
		Pagina 27 Page	di 29 of

<p>SERMS</p> <p>Laboratorio per lo Studio degli Effetti delle Radiazioni sui Materiali per lo Spazio</p> <p>Via Pentima Bassa, 21 Terni 05100 TR phone/fax: +39.0744.49.29.13</p>	<p>ENVIRONMENTAL TEST REPORT</p>	<p>doc: PDS TVT date: 07/09/09 rev: A02 pag: 1 /39 file: ENVRPT149_S2413R-A02-07SEP2K9</p>
--------------------------------------------------------------------------------------------------------------------------------------------------------------------------------------------------	---------------------------------------------	------------------------------------------------------------------------------------------------------------

The AMS-02 Power Distribution System Flight Model (PDS-PFM)

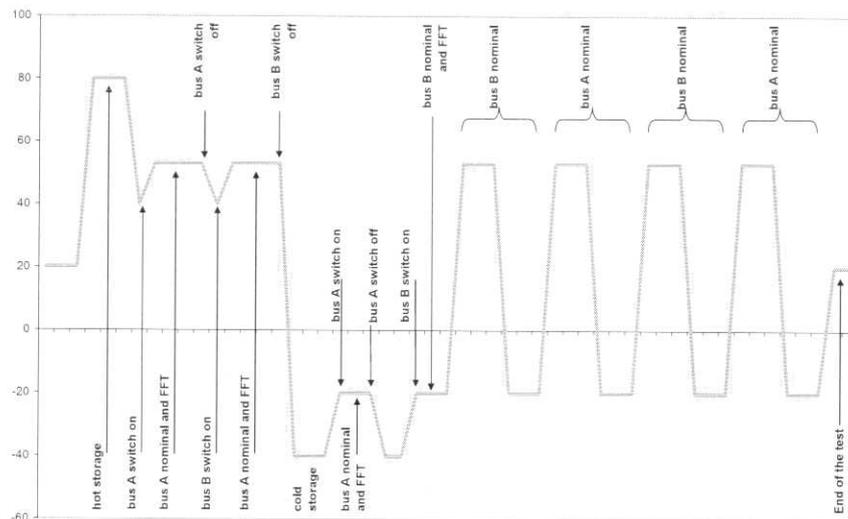
FIGURE 1 – TEST TEMPERATURE PROFILE.

Hot storage	+80°C
Hot operative	+53°C
Cold storage	-40°C
Cold operative	-25°C

The actual procedure adopted in the test is schematically presented in figure 1.

1. the approved reference profile on the customer procedure: PDS-PR-CGS-012 is.2 and the related PVS;
2. Subsequence modifications, as per the PVS generated during the test, have modified the profile according to the final layout which can be found in figure 27 (PDS TRP TEMPERATURE PROFILE)

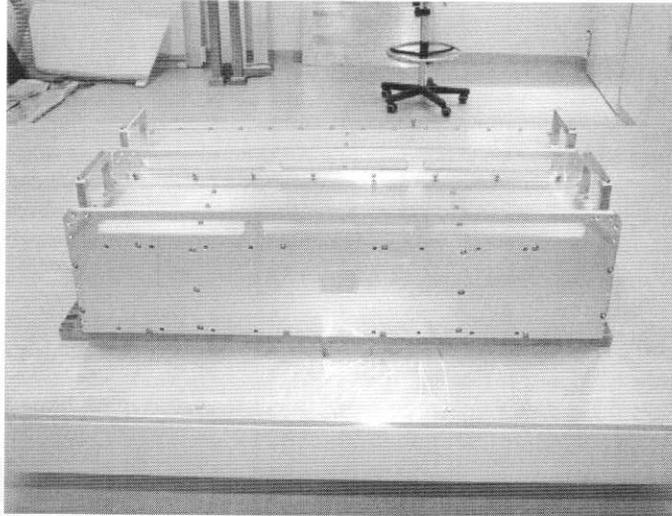
FIGURE 3 – PDS READY FOR THE SENSORS INSTALLATION.

The PDS-PFM has been fixed to the chamber lower cold plate by means of a aluminium fixture (provided by CGS). Cho-term (provided by CGS) has been placed between the PDS and the aluminium fixture.

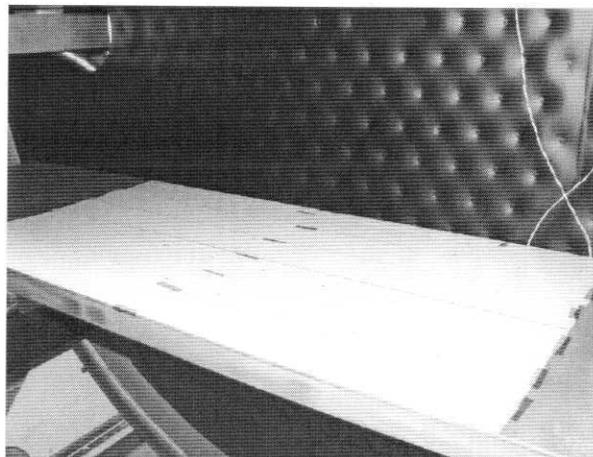
FIGURE 4 - DETAIL OF THE CHO-TERM USED BETWEEN THE PDS ALUMINIUM FIXTURE AND THE CHAMBER COLD PLATE.

Cho-term 1674 (provided by SERMS) has been placed between the aluminium fixture and the chamber cold plate (see FIGURE 4).

The aluminium fixture has been fixed to the chamber cold plate using n°29 M4 screws. The torque value used was 2.0 Nm. Two of these screws have not been locked using the nominal torque due to some problems with the metallic insert of the IF plate of the PDS.

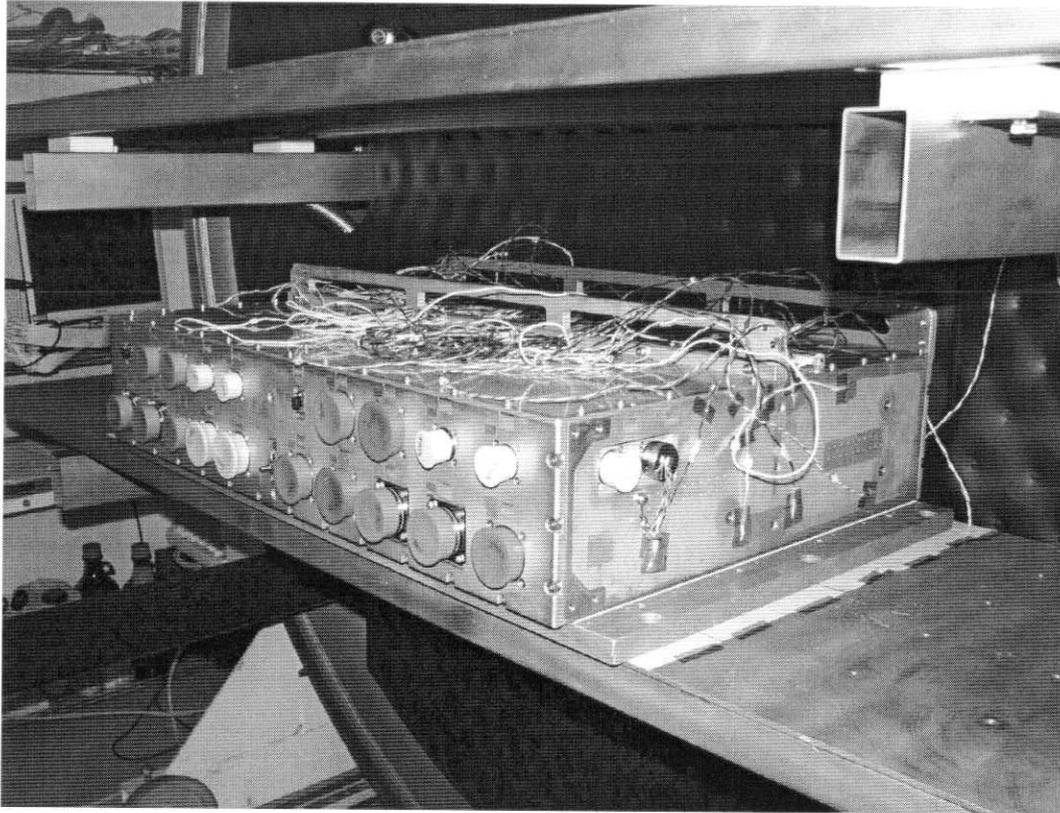
FIGURE 5 – HARDWARE POSITIONING INSIDE THE TVC. THE PDS HAS BEEN FIXED TO THE CHAMBER LOWER COLD PLATE.

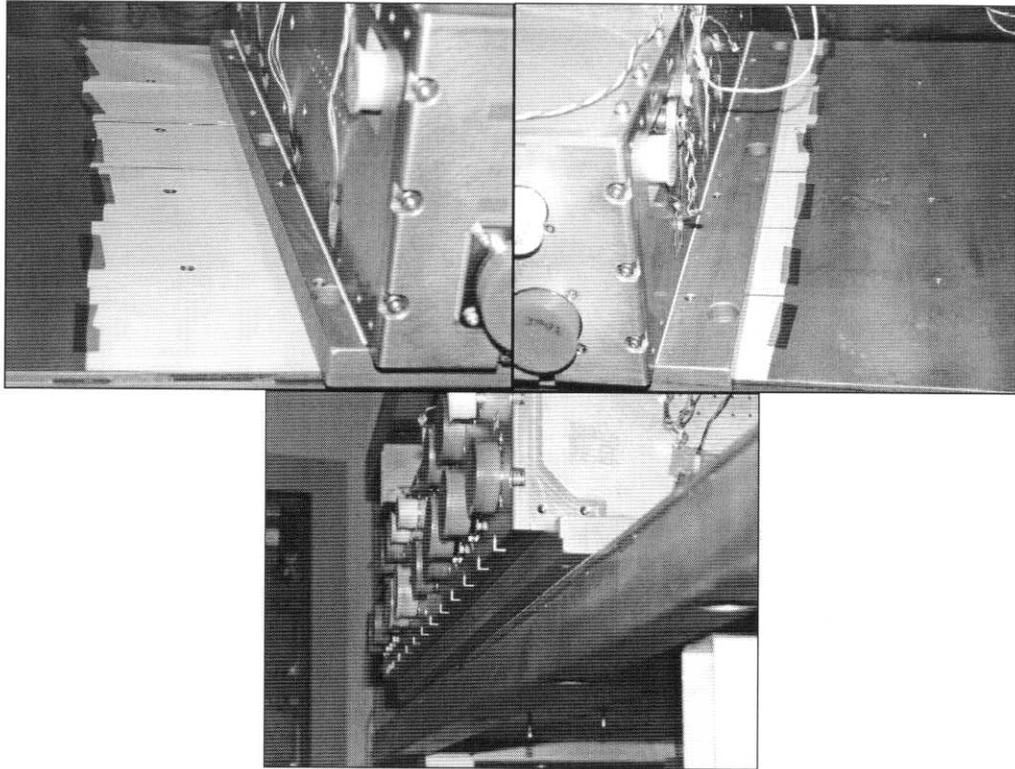
FIGURE 6 – DETAIL OF THE PDS FIXTATION ON THE CHAMBER COLD PLATE.

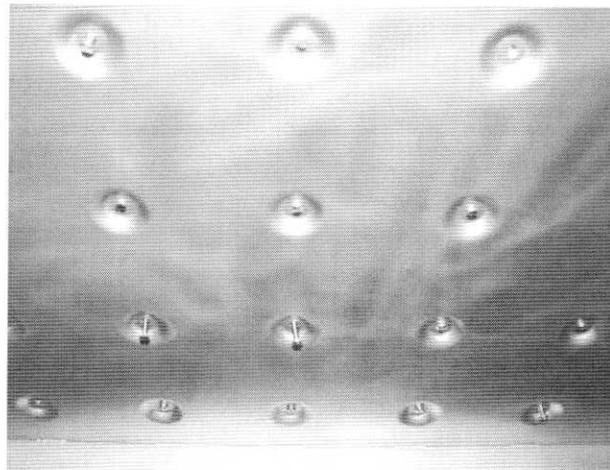
FIGURE 7 – DETAILS OF THE M4 SCREWS USED TO FIX THE PDS ALUMINUM FIXTURE TO THE CHAMBER COLD PLATE.

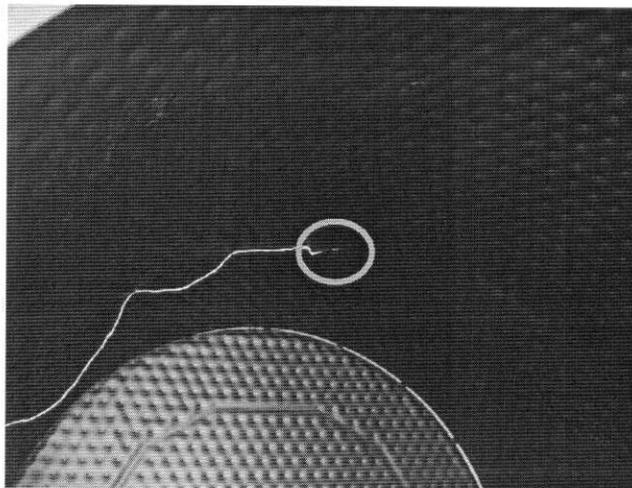
FIGURE 8 – CHAMBER SENSOR 4.

- 3 TS were placed on lower cold plate near the PDS fixture: one sensors (ch 5) has been used to control the cold plate temperature while the other two sensors (ch8 and ch9) were used for redundancy reasons.
- 2 TS were placed on the other two cold plate to control their temperature: ch6 on middle cold plate and ch7 on upper cold plate.
- 1 TS was placed on the chamber shroud to control its temperature during the test (ch4).

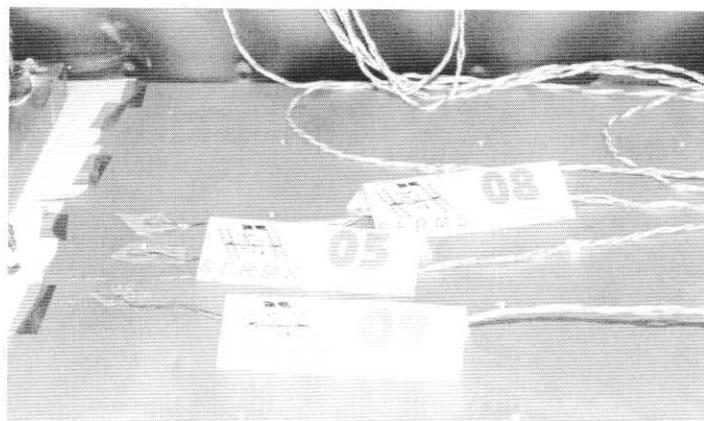
FIGURE 9 – COLD PLATE SENSOR PT n° 05 (to control the cold plate temperature), PT n°08 and PT n°09 (to monitor the cold plate temperature).

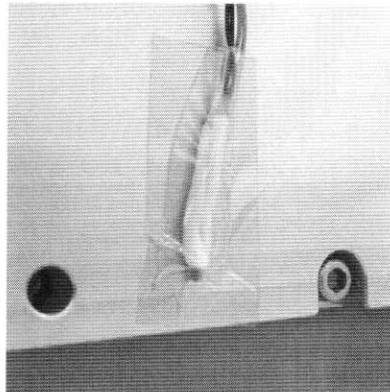
FIGURE 10 – DETAILS OF SENSORS POSITIONING: ALL THE SENSORS HAVE BEEN PLACED USING KAPTON TAPE.

All the sensors were fixed on the PDS using Kapton tape and covered with Aluminium tape in order to minimize the radiative effect.

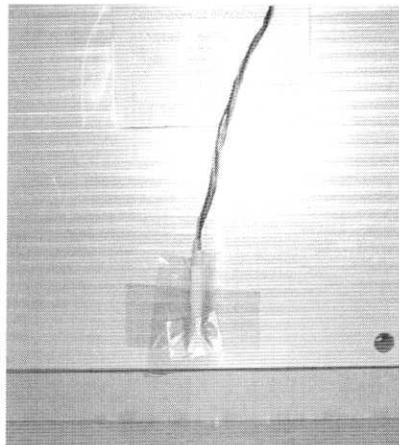
FIGURE 11 – DETAIL OF THE SENSORS POSITIONING: ALL THE SENSORS HAVE BEEN COVERED WITH ALUMINUM TAPE.

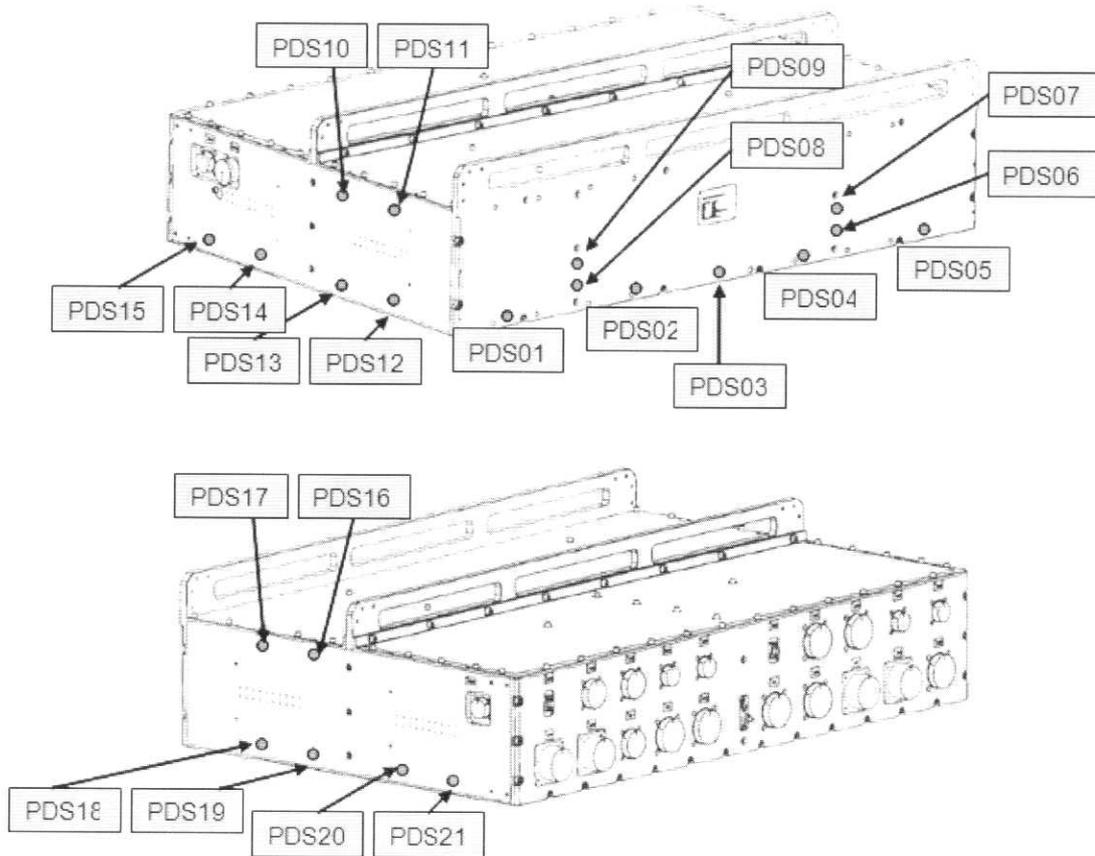
FIGURE 12 – SENSORS POSITION ON FRONT/LATERAL WALLS OF PDS.

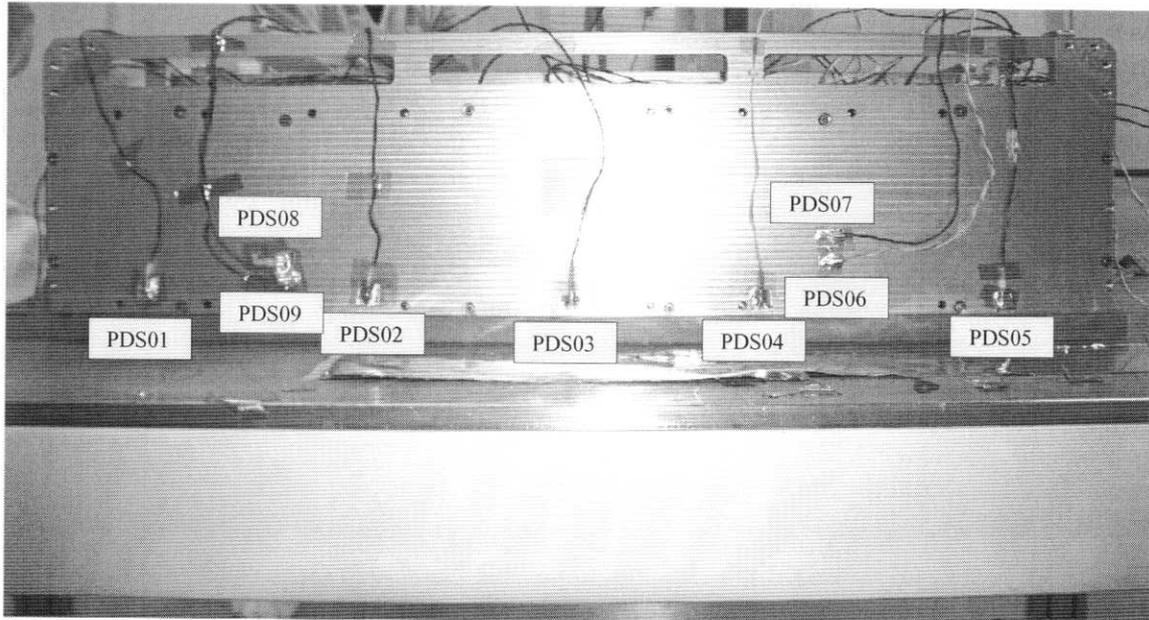
FIGURE 13 – BACK WALLS SENSORS POSITIONING. THE PDS01 SENSOR WAS UN-OPERATIVE. ITS MALFUNCTIONING DID NOT AFFECT THE TEST EXECUTION. ALL THE SENSORS ARE FIXED WITH KAPTON TAPE AND COVERED WITH ALUMINUM TAPE.

After positioning, all sensors have been tested to verify possible failures after installation and one of them resulted un-operative: external sensor PDS 01.

After detector disassembly broken connections at soldering points were traced as reason for this problem.

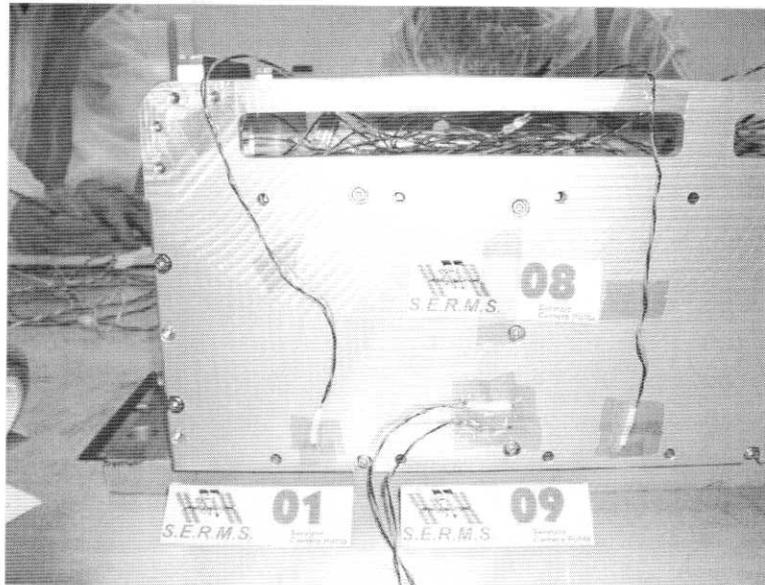
FIGURE 14 – DETAIL OF THE PDS08 AND PDS09 POSITIONING WITH KAPTON TAPE. THESE SENSORS HAVE BEEN USED AS TRP FOR BUS A OF THE PDS.

A total of 31 Thermal Sensors have been installed on the PDS-PFM by CGS personnel and S.E.R.M.S. personnel under the direction of CGS personnel. All the sensors have been installed on the external walls of the PDS. Four of these sensors (PDS06, PDS07, PDS08, PDS09) have been used as Temperature Reference Points of the test. PDS06 and PDS07 (the main is the PDS06 while the PDS07 is the redundant) are the two TRP for the PDS Bus B; PDS 08 and PDS09 (the main is the PDS08 while the PDS09 is the redundant) are the two TRP for the PDS Bus A.

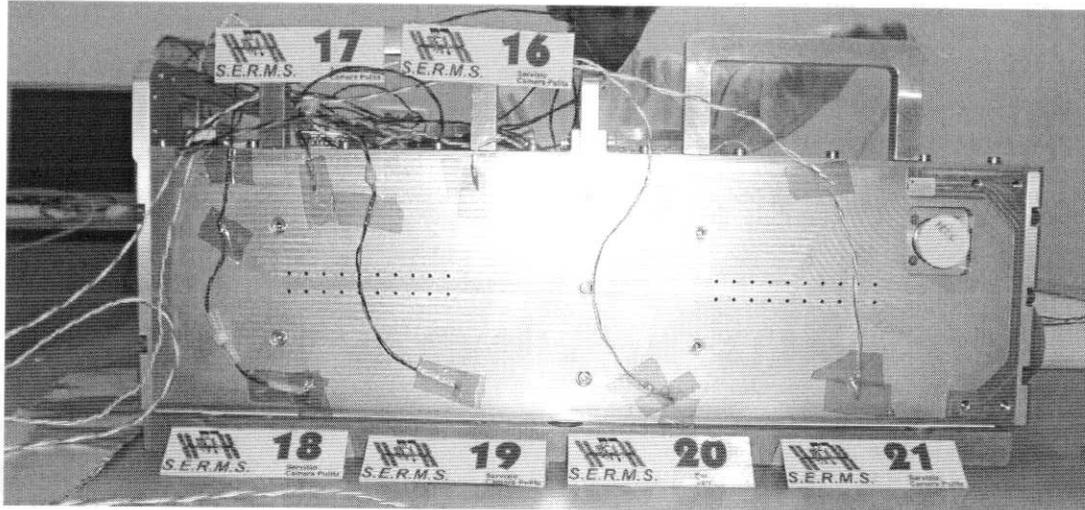
FIGURE 15 – DETAIL OF THE SENSORS POSITIONING ON ONE LATERAL WALL OF THE PDS.

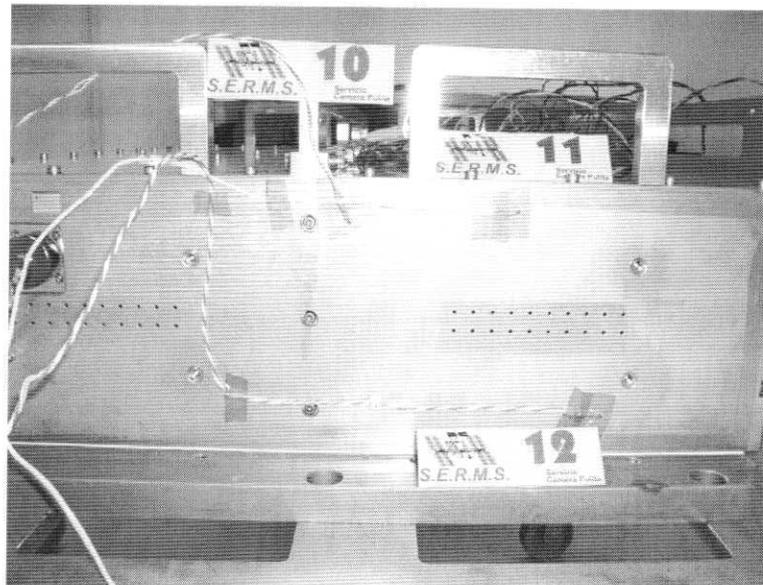
FIGURE 16 – DETAIL OF THE SENSORS POSITIONING PDS 10, PDS11, PDS12 ON ONE LATERAL WALL OF THE PDS.

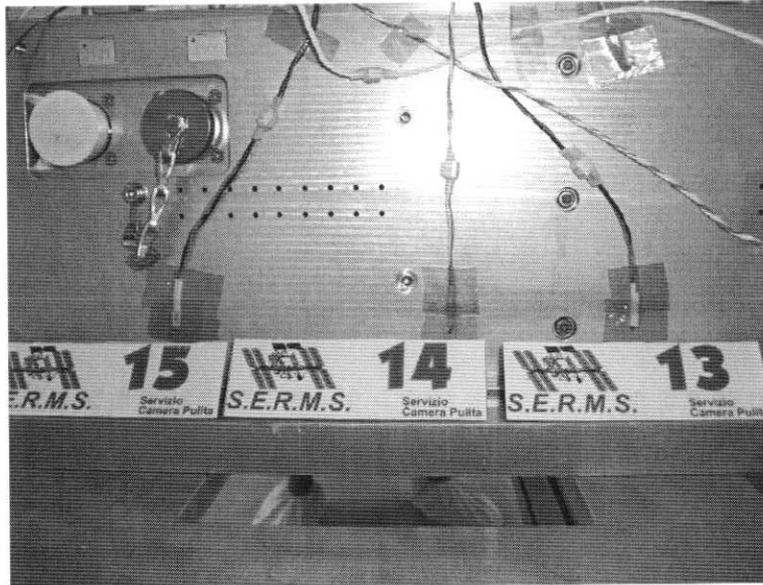
FIGURE 17 – DETAIL OF THE SENSORS POSITIONING PDS 13, PDS14, PDS15 ON ONE LATERAL WALL OF THE PDS.

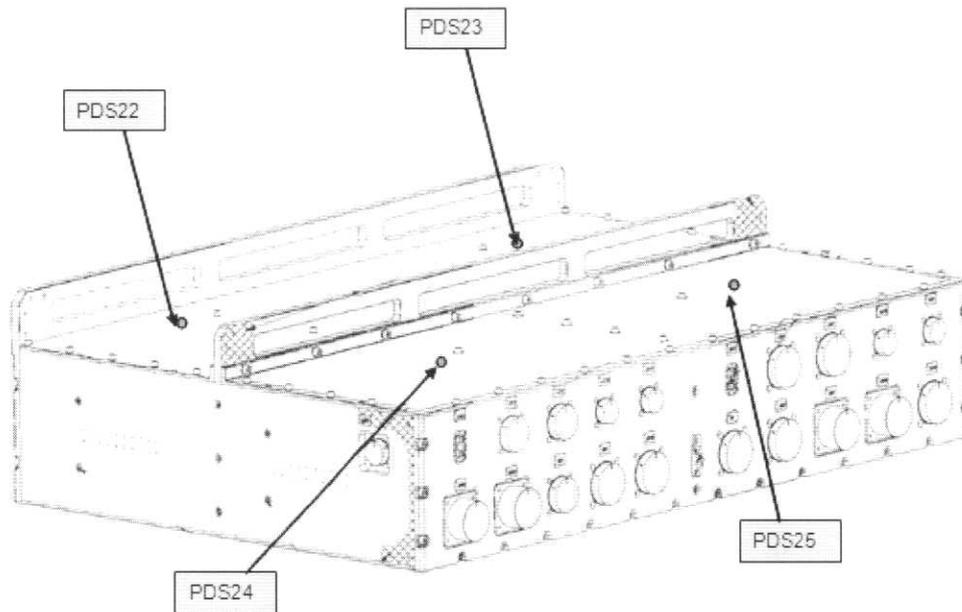
FIGURE 18 – SENSORS POSITION ON TOP COVER.

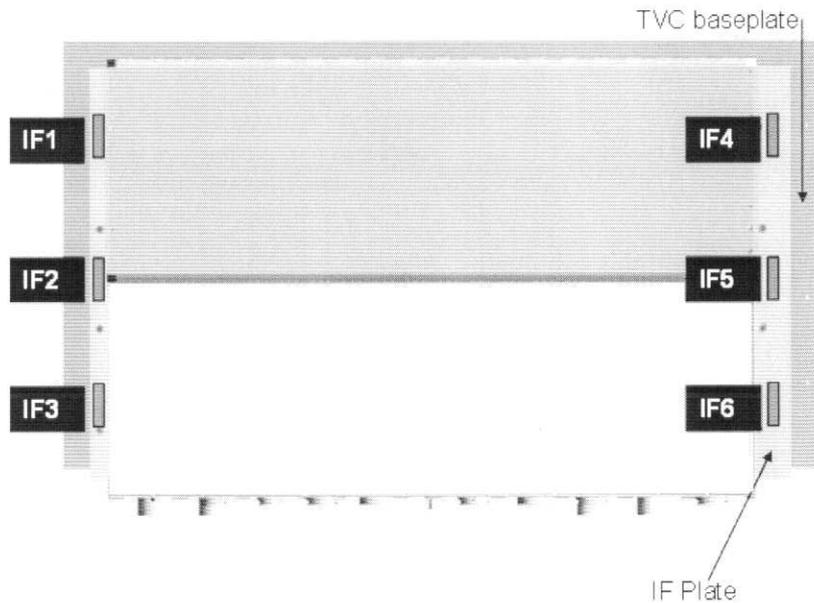
FIGURE 22 – EXTERNAL IF PLATE SENSORS POSITION.

Other sensors shall be positioned on the interface plate in order to measure the temperature impedance given by the contact connection between PDS baseplate, and IF plate.

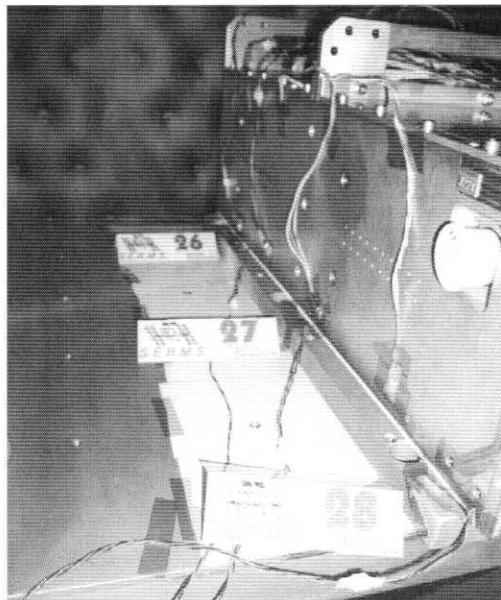
FIGURE 23 – EXTERNAL SENSORS POSITION: IF1 IS THE CH26, IF2 IS THE CH27, IF3 IS THE CH28.

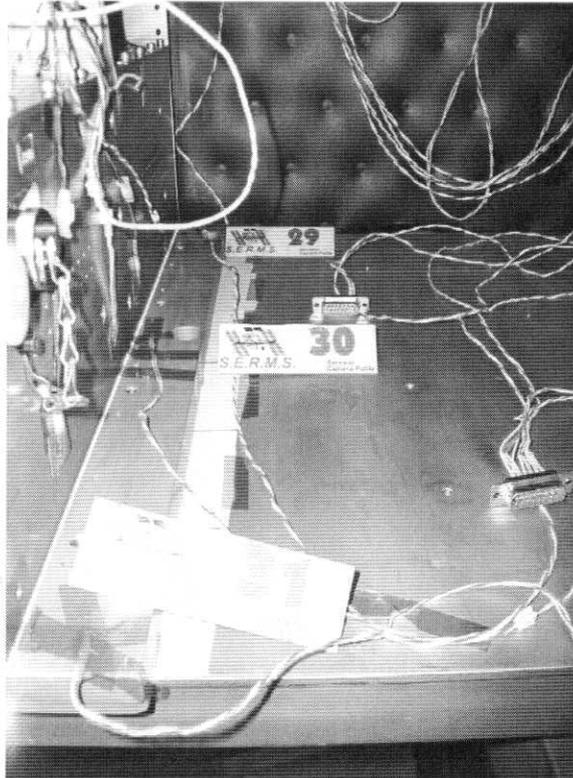
FIGURE 24 – EXTERNAL SENSORS POSITION: IF4 IS THE CH29, IF5 IS THE CH30, IF6 IS THE CH31.

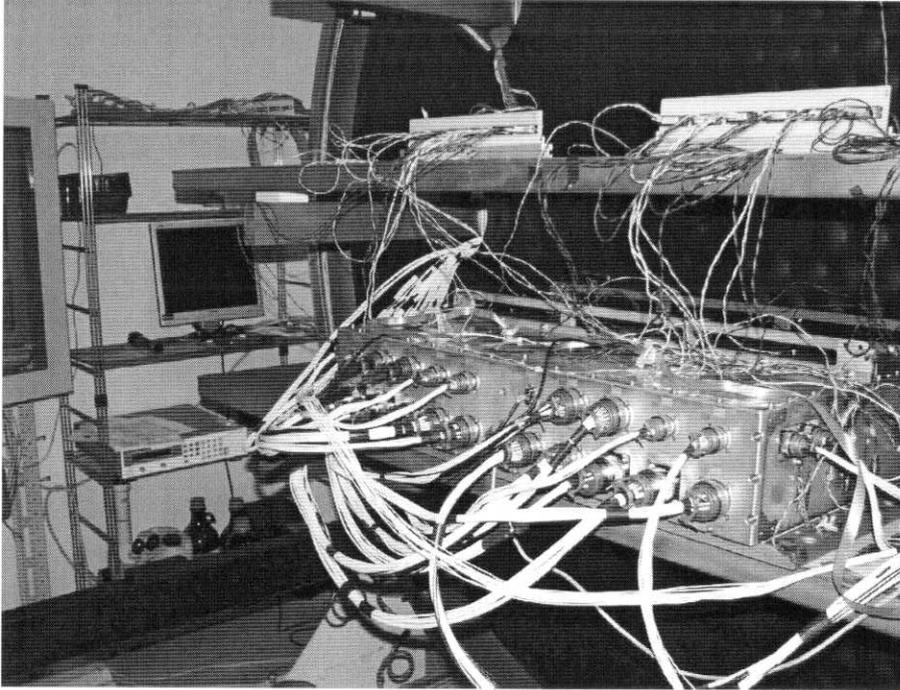
FIGURE 25 – CABLING OF THE PDS.

Before to start the tests the PDS has been cabled and completely covered with MLI (Multi Layer Insulation).

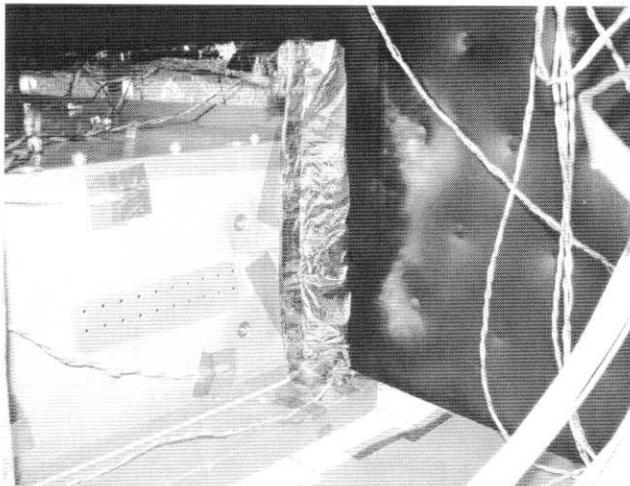
FIGURE 26 – DETAIL OF THE MLI POSITIONING.

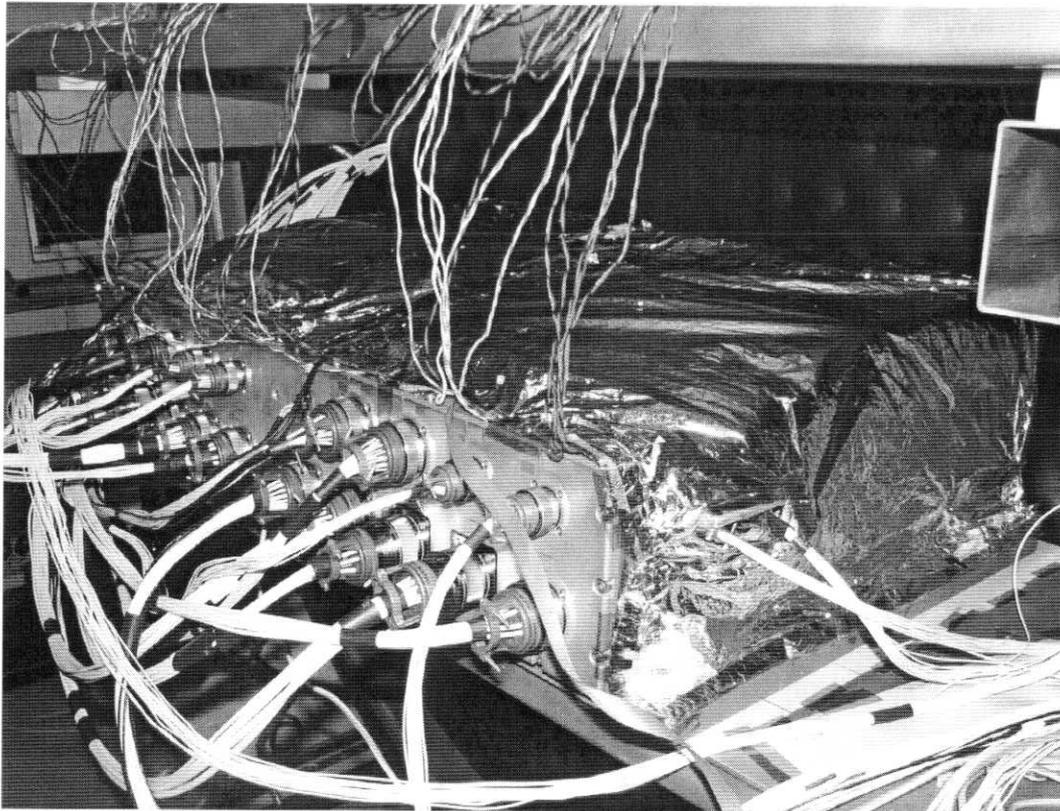
FIGURE 27 – PDS COVERED WITH MLI AND READY TO BE TESTED.

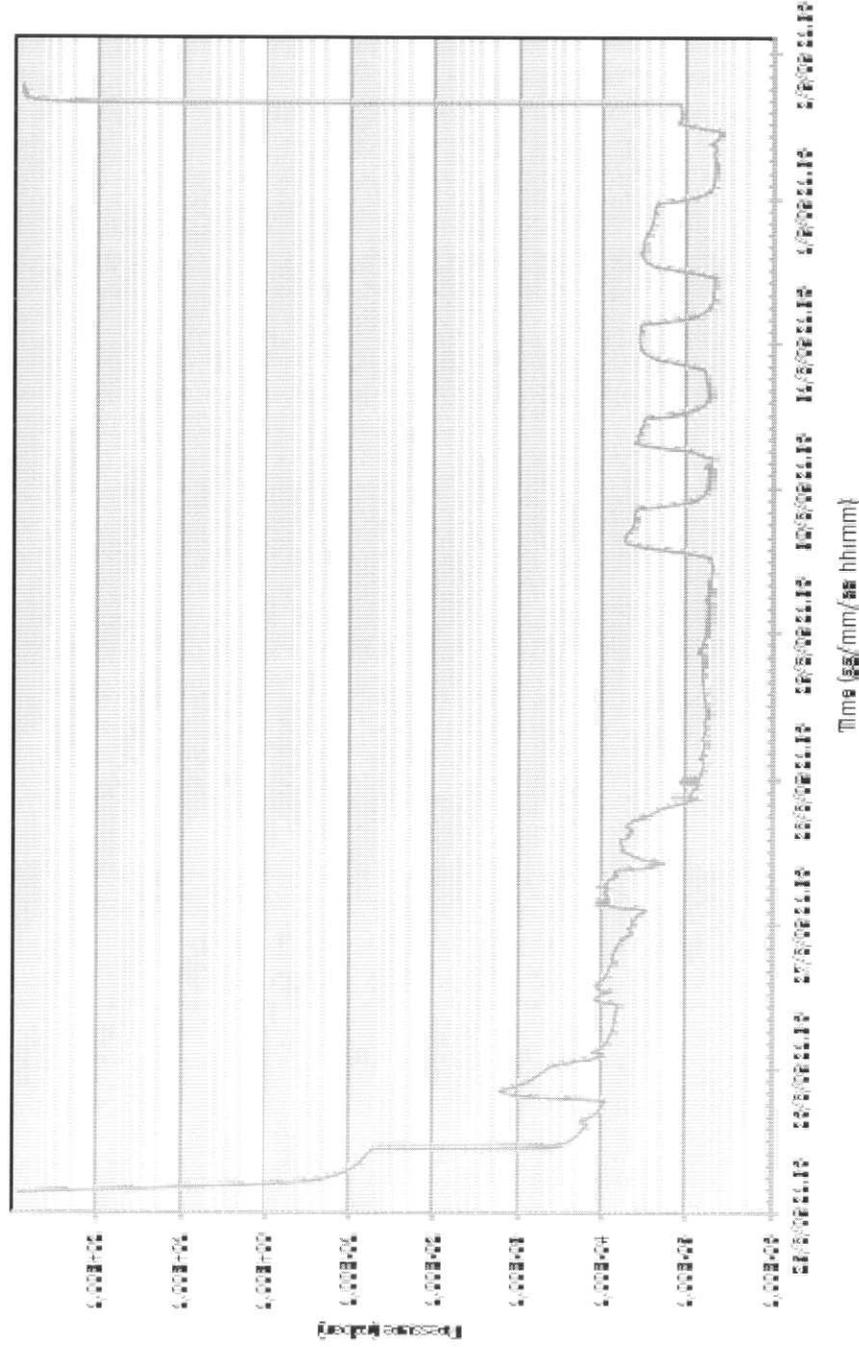
FIGURE 28 – PRESSURE PROFILE OF THE TEST.

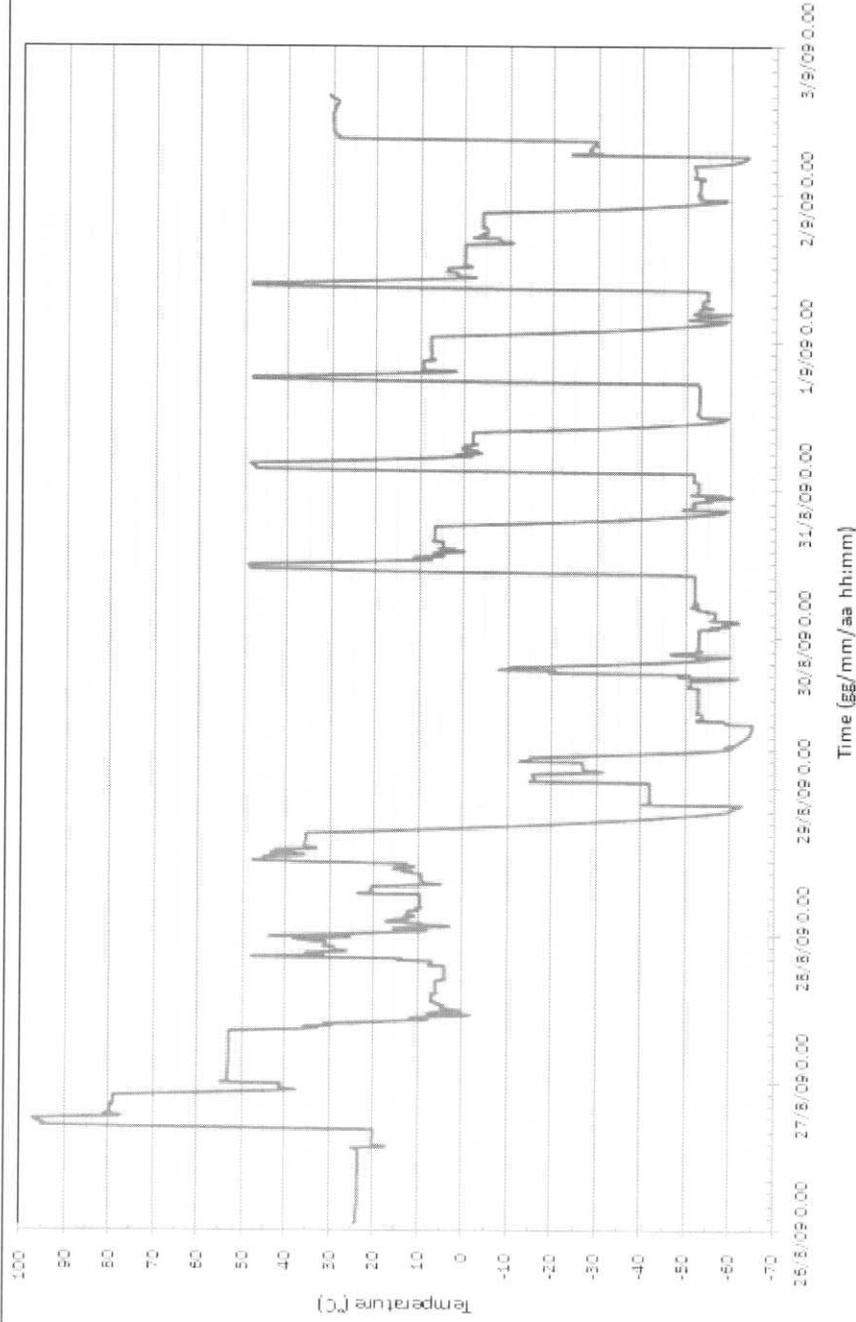
FIGURE 29 – LOWER COLD PLATE TEMPERATURE PROFILE: CH5 SENSOR.

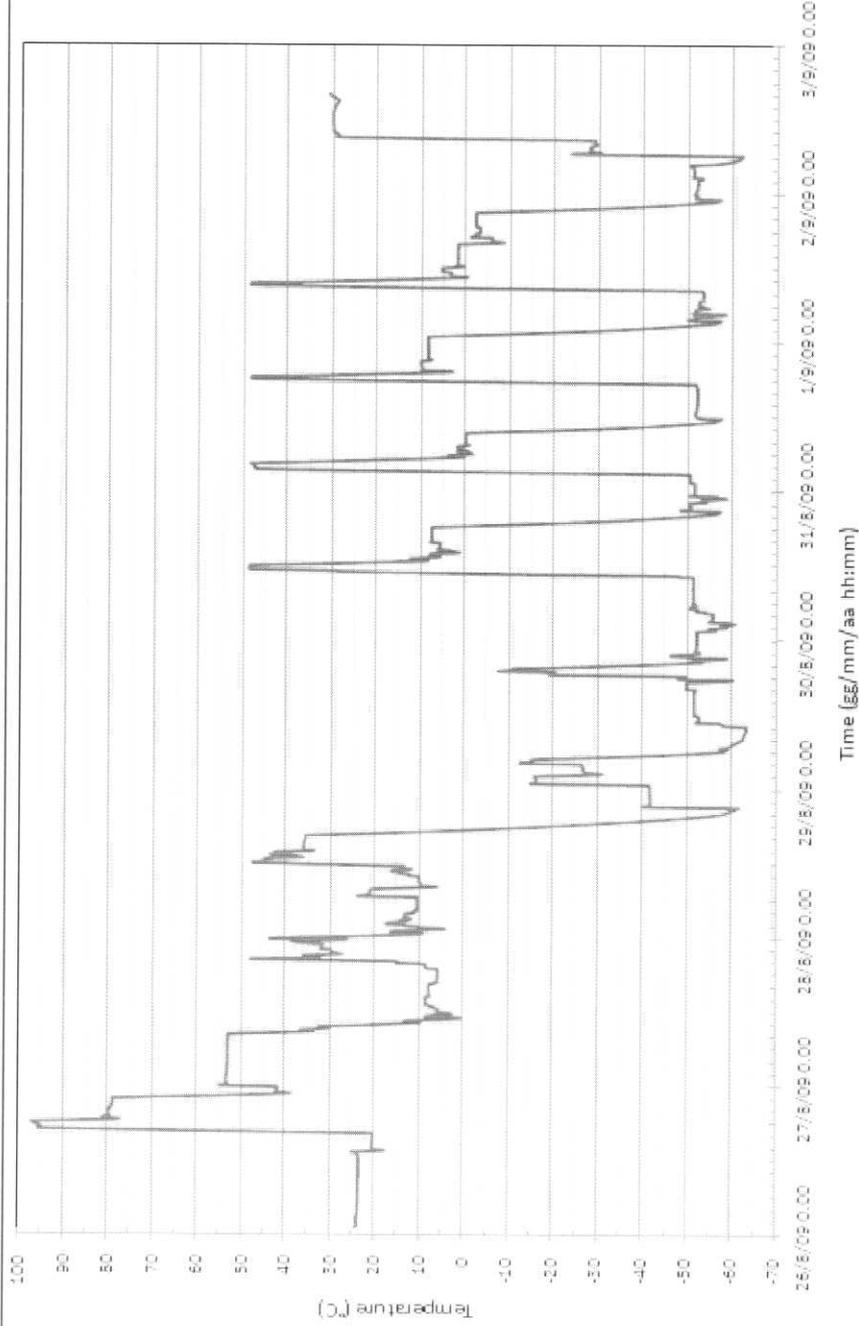
FIGURE 30 – LOWER COLD PLATE TEMPERATURE PROFILE: CH8 SENSOR.

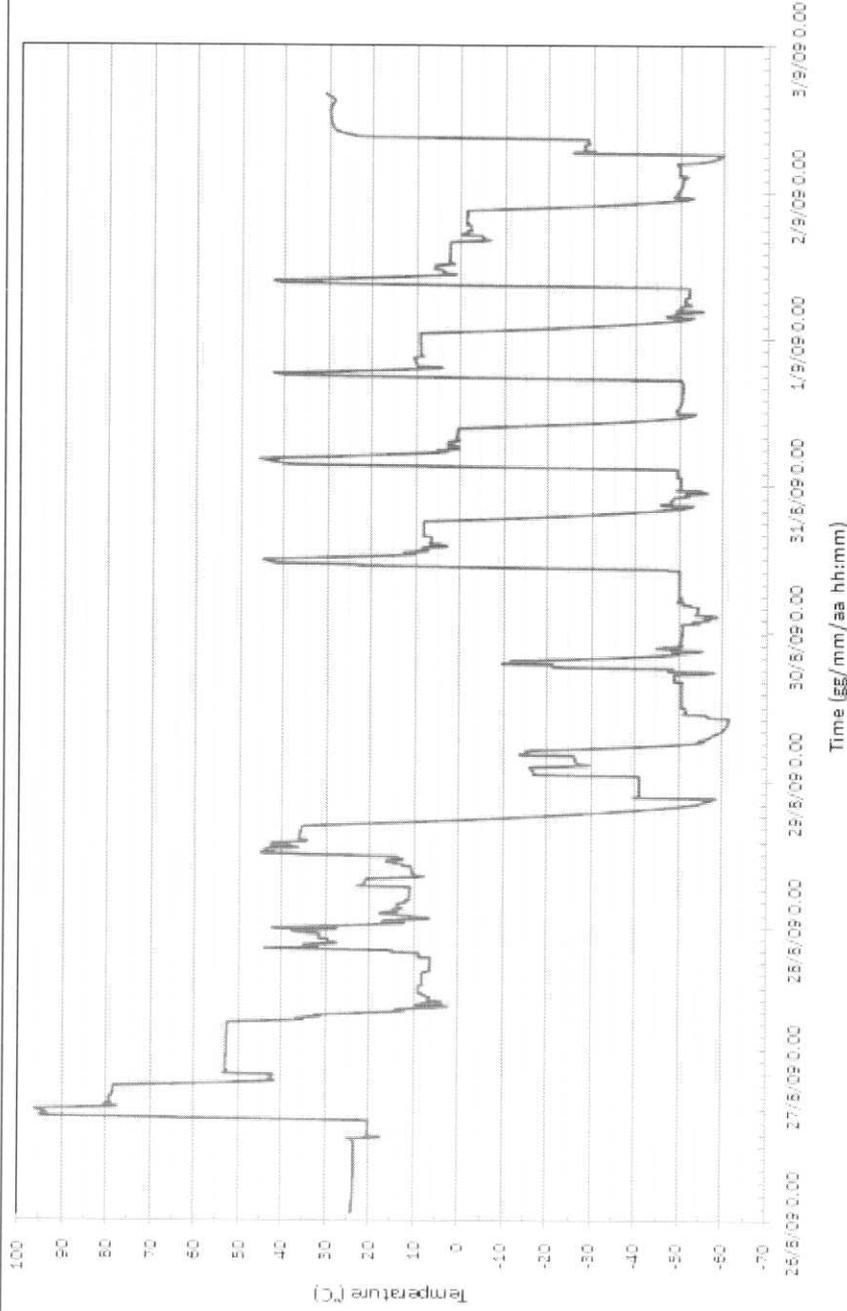
FIGURE 31 – LOWER COLD PLATE TEMPERATURE PROFILE: CH9 SENSOR.

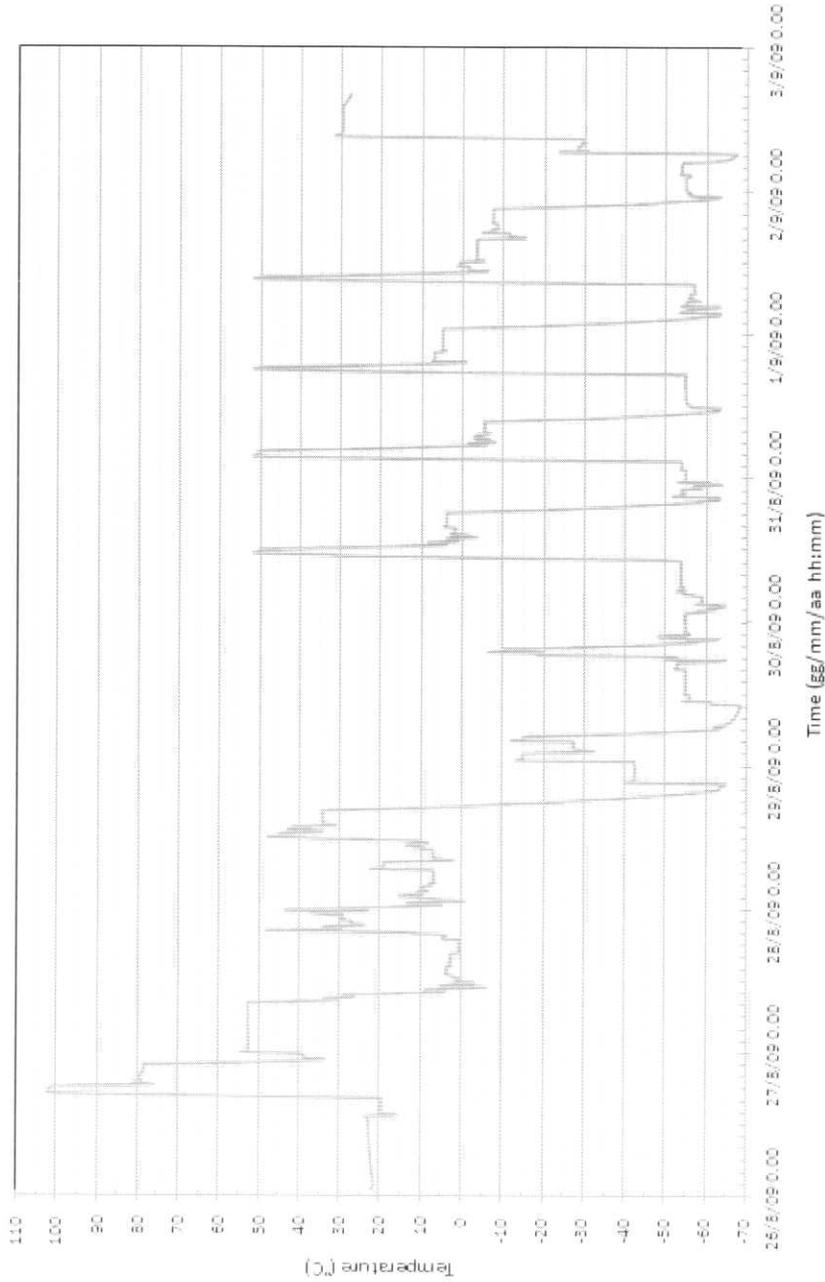
FIGURE 32 – MIDDLE COLD PLATE TEMPERATURE PROFILE: CH6 SENSOR.

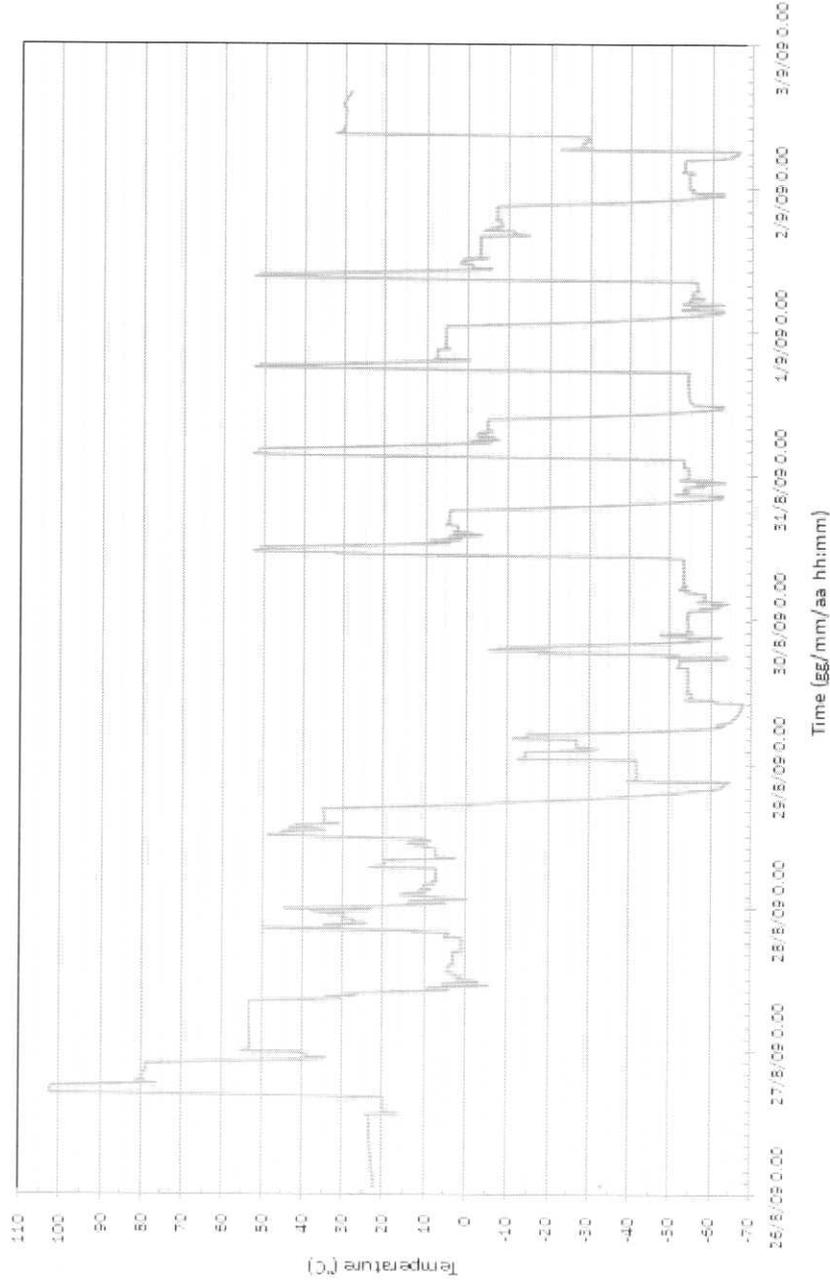
FIGURE 33 – UPPER COLD PLATE TEMPERATURE PROFILE: CH7 SENSOR.

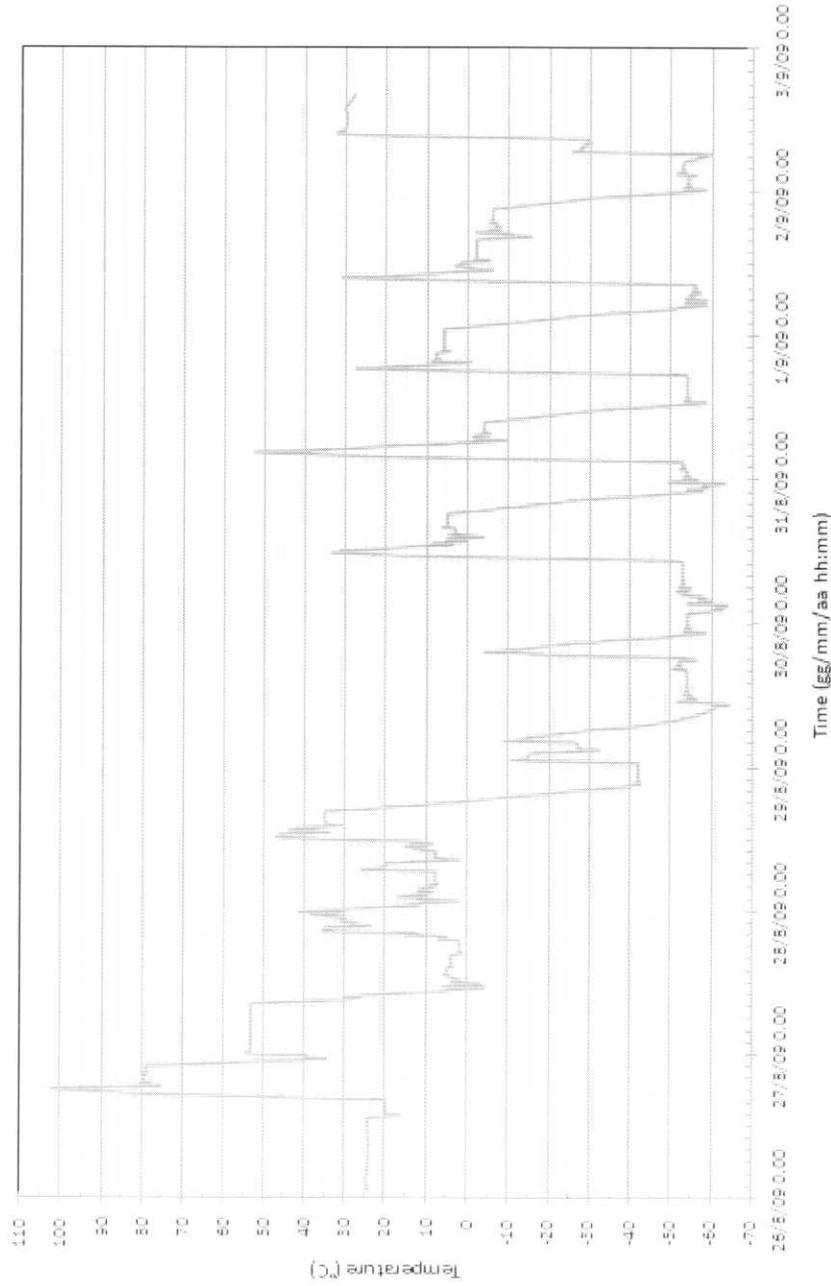
FIGURE 34 – SHROUD TEMPERATURE PROFILE: CH4 SENSOR.

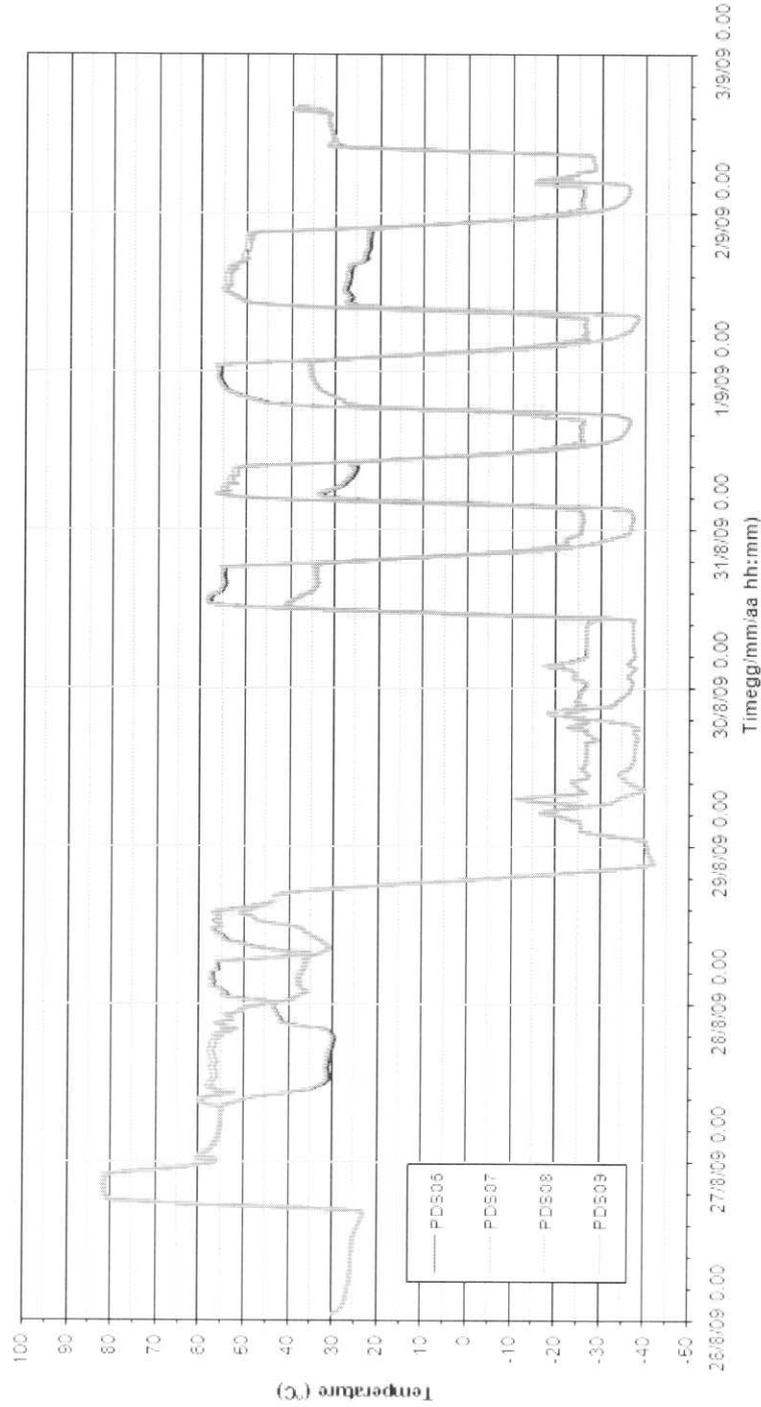
FIGURE 35 – PDS TRP TEMPERATURE PROFILE.

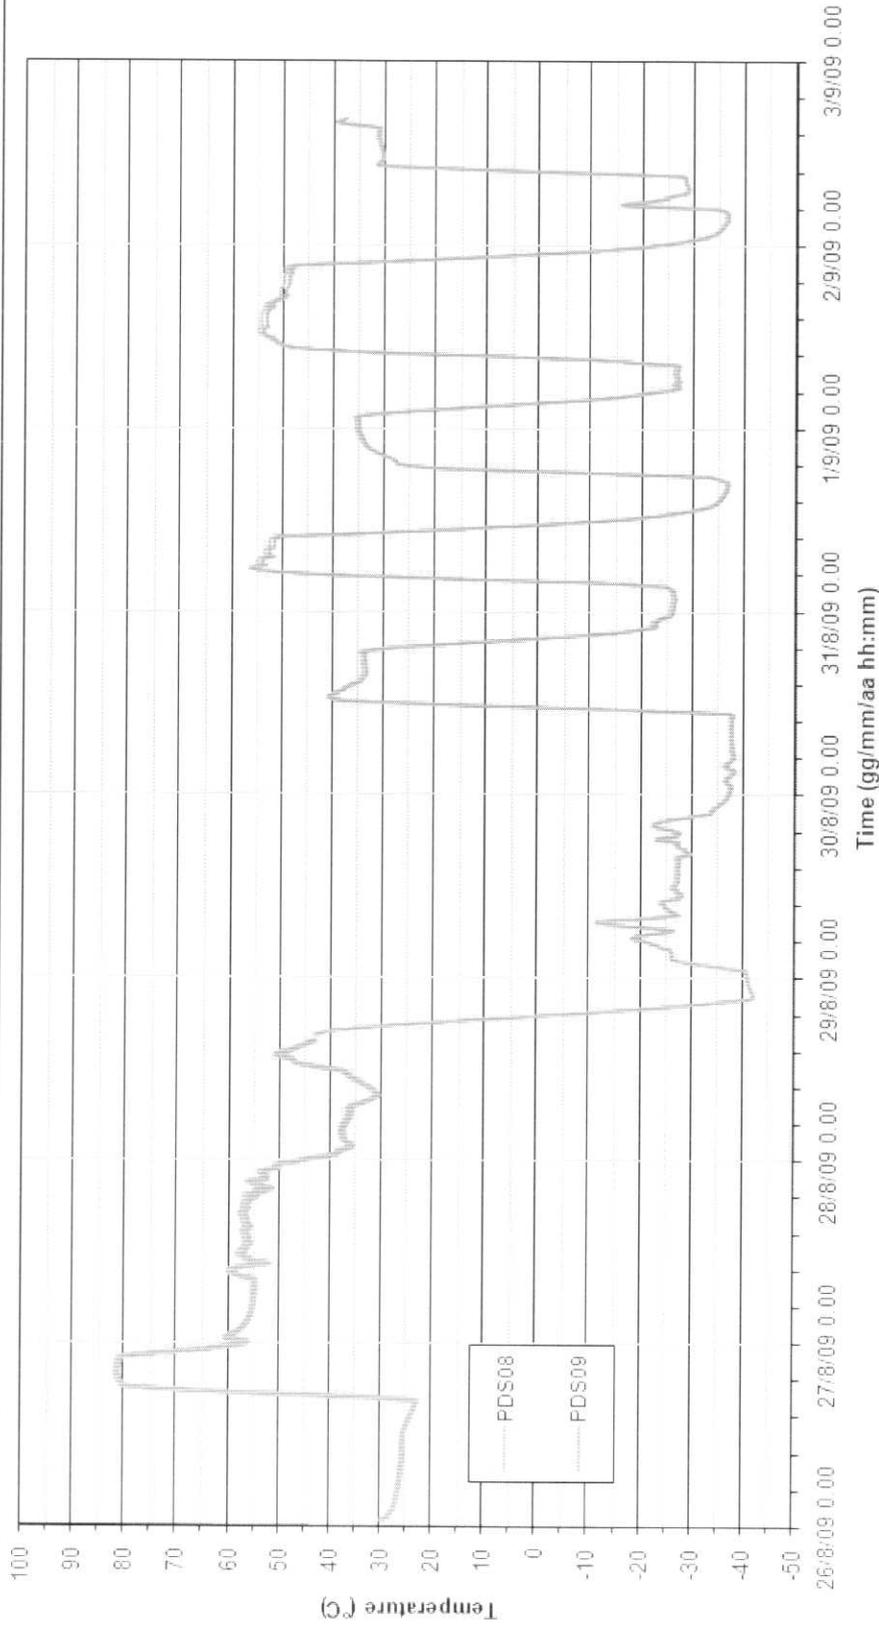
FIGURE 36 – PDS-BUS A TRP TEMPERATURE PROFILE.
